Manhole Inspection Summary

Manhole # S21K__018MH

Insp Date: **4/3/08 12:48 PM**

Location Address: **341 s payson-goldsmith alley**

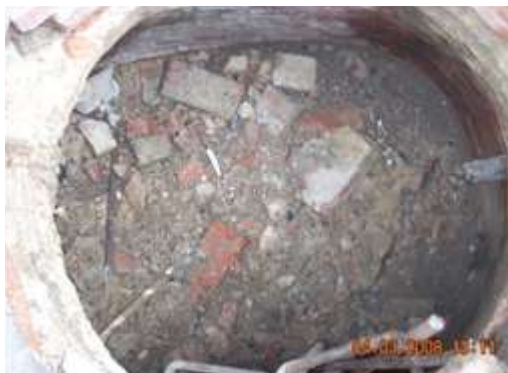
Defect 4

Condition: ☐ Sound ☐ Cracked ☐ Root Intrusion ☐ Deteriorated ☐ Leaks ☒ Debris

debris in terminal channel

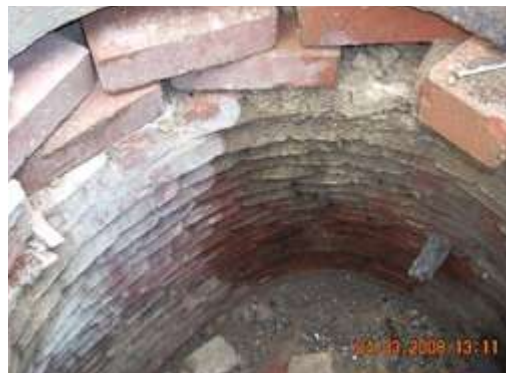
Defect 3

Infiltration: ☐ None ☒ Joint ☐ Cracks ☐ Mortar ☐ Roots ☐ Wall

infiltration @ chimney joint

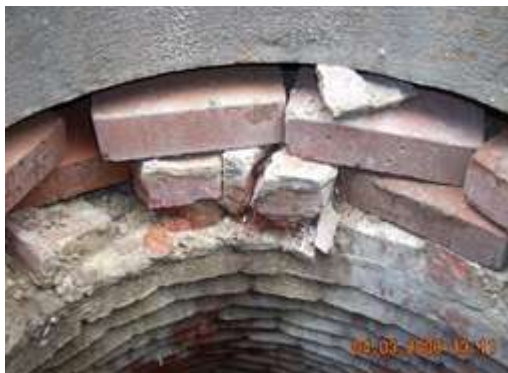
Defect 2

Condition: ☐ Sound ☐ Cracked ☐ Root Intrusion ☒ Loose Brick ☒ Deteriorated

deteriorated corbel/loose corbel and chimney bricks

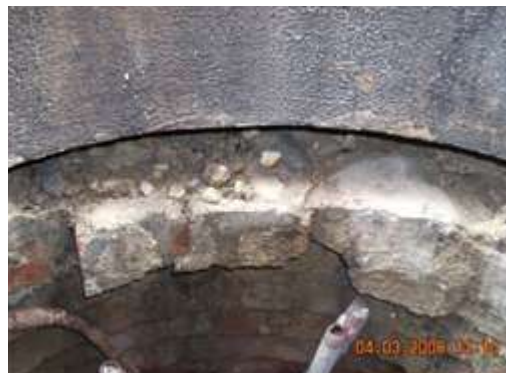
Defect 1

Condition: ☐ Sound ☐ Cracked ☐ Root Intrusion ☒ Loose Brick ☒ Deteriorated

deteriorated chimney

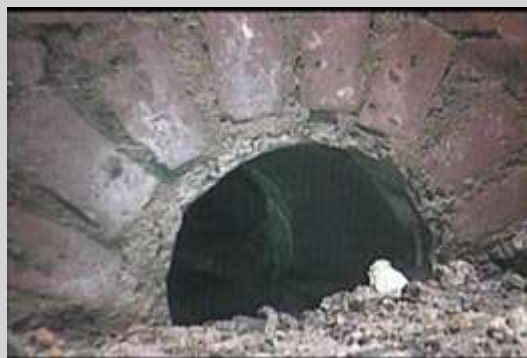
12 O'Clock Outflow

8 in. Circular Gravity Sewer
Pipe Out @ 12 O'Clock

Deposits: ☐ None ☒ **Mud** ☐ Sludge ☐ Debris ☐ Grease

Silt Depth: **3** (in.) Deposits Extent: **Medium**
